# GEOMORPHIC EFFECTS OF LARGE DEBRIS FLOWS ON CHANNEL MORPHOLOGY AT NORTH FORK MOUNTAIN, EASTERN WEST VIRGINIA, USA

DANIEL A. CENDERELLI\* AND J. STEVEN KITE

## ABSTRACT

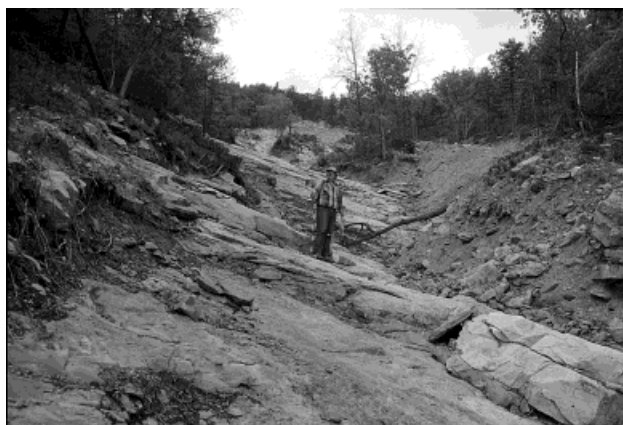
Figure 6. Photograph of the Twin Run failure zone. Failure zones are marked by distinct vertical scarps along the failure margin. Note that the depth of failure is greatest where bedrock is exposed

Failure zones are steep and situated in unchannelized hollows, planar side slopes, or a combination of both. Distinct scarps, up to 2.5 m high, along the upper and lateral margins of the failure zones, distinguish failure surfaces from adjacent undisturbed slopes (Figure 6). Undisturbed sediment exposed in the scarps indicates that the failed material consisted primarily of a clast-supported sandy, bouldery diamicton derived from orthoquartzite. The failed material also included trees and shrubs growing on the surface of the pre-failure sediment.

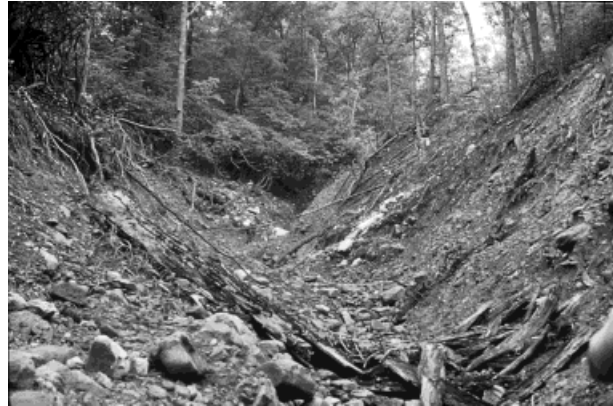
Figure 7. Photograph of the Twin Run transport/erosion zone. Transport/erosion zones are characterized by scoured channel side slopes and channel floors. Note the tree and shrub roots exposed and overhanging the eroded side slope

Transport/erosion zones are characterized by scoured channel side slopes and floors (Figure 7). Debris-flow erosion exposed fresh outcrops of bedrock or diamicton (Figures 2–4). Typically, the surface immediately above the eroded slope is undercut, exposing tree and shrub roots (Figure 7). Eroded surfaces have lengths of 10 to 200 m, heights of 3 to 11 m, and erosion depths up to 2 m. The debris flows removed most of the vegetation within the transport/erosion zones and scarred trees along the outer margins of the flow. Spill-over chutes, formed when part of the debris-flow mass flowed out of the pre-existing channel and re-entered the channel further downstream, were identified on Twin Run (Figure 4). A few sheared root masses on the spill-over chute surface suggest that the depth of erosion was less than 0.3 m.

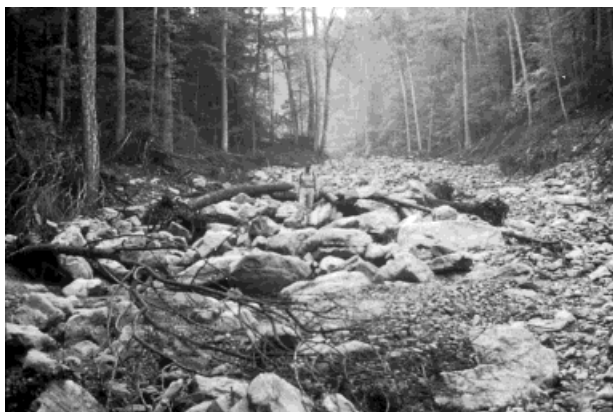
Figure 8. Photograph of a clast-supported lobate boulder deposit in the Twin Run deposition zone

Lobate boulder deposits and boulder terraces are the dominant type of debris-flow deposits in the deposition zones (Figures 2–5). The flanks of lobate boulder deposits are detached from valley side slopes, whereas one of the flanks of the boulder terraces is attached to a valley side slope. These deposits have steep fronts and flanks, generally small-scale undulations on their surfaces, lengths of 6 to 138 m, widths of 2 to 48 m, thicknesses of 0.3 to 2.5 m, and areas of 5 to 5220 m<sup>2</sup>. Lobate boulder deposits and boulder terraces are poorly to very poorly sorted, clast-supported, not imbricated, massive or inversely graded, and composed primarily of very angular or angular boulders and cobbles, pebbles and sand (Figure 8). Sand and pebbles occupy the interstices between the boulders and cobbles except for the upper 0.3 to 0.5 m of the deposit surfaces. For the most part, the long-axes of cobbles and boulders show no preferred orientation, but small clusters of clasts with weakly developed long-axis orientations perpendicular, parallel or oblique to flow direction occasionally occur in parts of the deposits. The cobbles and boulders are mostly orthoquartzite, the predominant rock type in each source area. The largest clasts are usually concentrated at the surface and downstream ends of each deposit (Figure 8). Clasts do not

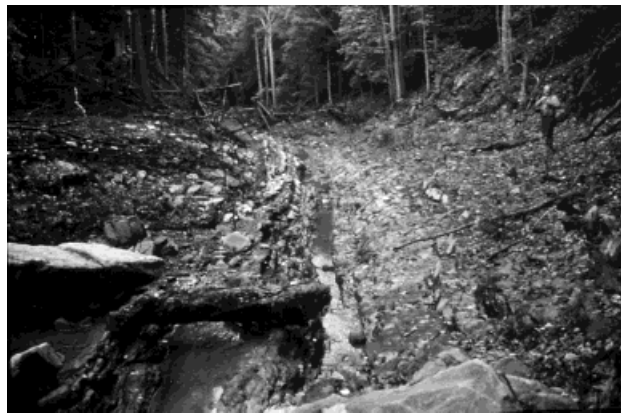
Figure 9. Photograph of a scoured channel floor in the Twin Run sediment-laden floodwater zone. View is just downstream of the Twin Run debris-flow terminus

Channels located immediately downstream from the deposition zones experienced intense erosion and deposition by hyperconcentrated flow or sediment-laden floodwaters (Figure 9). These zones are characterized by thin, clast-supported sheet deposits, undercut side slopes and scoured channel floors (Figures 2, 3 and 5). Sheet deposits are clast-supported, strongly imbricated with the long-axis of most clasts oriented perpendicular to flow direction, and composed primarily of cobbles and small boulders. These physical characteristics suggest that the sheet deposits formed from water-flood processes (Smith, 1986; Wells and Harvey, 1987; Costa, 1988). Sheet deposits on Austin Run and Gravel Lick Run have lengths of 6 to 54 m, widths of 1.5 to 30.0 m, thicknesses of 0.3 to 1.5 m, and areas of 10 to 1440 m<sup>2</sup>. Erosion was most extensive on Austin Run and Gravel Lick Run, particularly at valley constrictions where side slopes were undercut (Figures 2 and 5). Eroded valley side slopes on Austin Run and Gravel Lick Run have lengths of 12 to 120 m, heights of 1.5 to 12.0 m and erosion depths up to 2.5 m.
